CANADIAN FORCES FLIGHT SAFETY INVESTIGATION REPORT

FILE NUMBER: 1010-C-GCLN (DFS 2-4-2)

AIRCRAFT TYPE: Schweizer 2-33 Glider

LOCATION: Miramichi Airport, New Brunswick

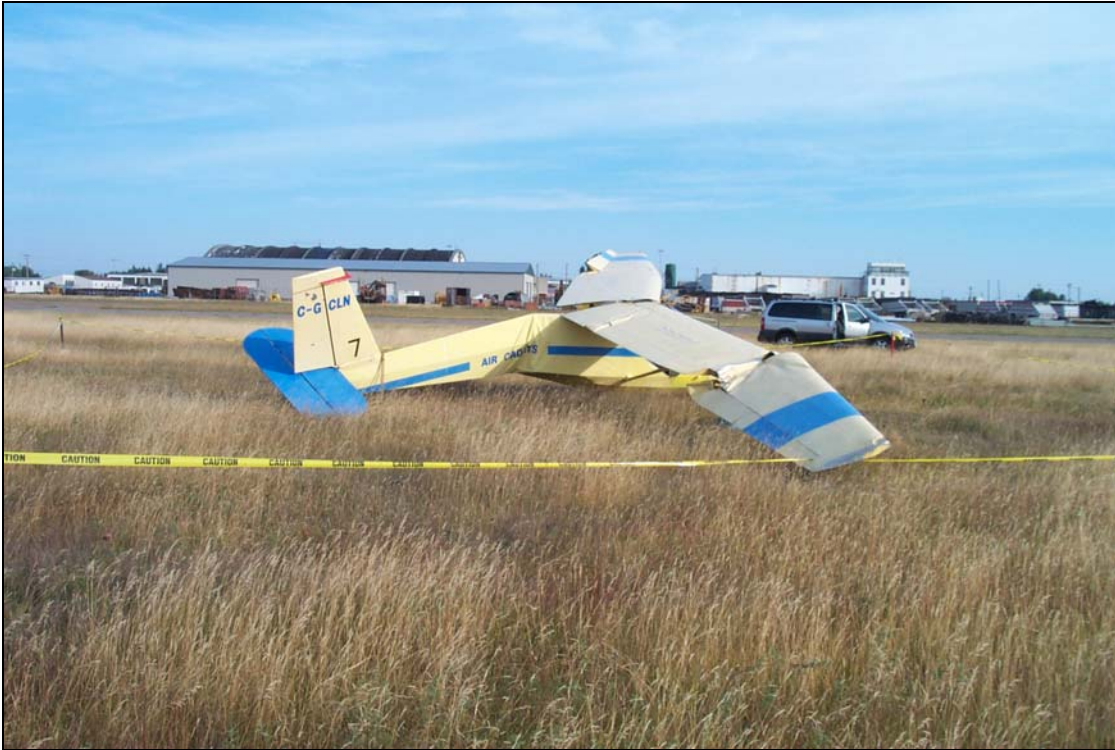
The aircraft received A Category damage (photo 1). Both wingtips contacted the ground, the right wing broke in two pieces at the inboard end of the aileron, and the underside of the nose cone was pushed inward (photo 2). The left wing rear spar attachment point sheared (photo 3) and allowed the wing to rotate forward causing damage to the canopy frame and to the skylight. The rear fuselage bent at the midpoint (photo 4) and the tail wheel broke-off.

The glider was in a medium to steep right turn when the right wingtip contacted the ground on the grass infield adjacent to the runway. This initial contact damaged the right wing and caused the aircraft to yaw to the right and to impact the ground on the underside of the nose in a steep nose down attitude. Under the impact load, the left wing's rear spar attachment point sheared off and the left wing rotated forward until the wingtip contacted the ground. The fuselage then fell back to the ground and the glider came to rest in the position shown in photo 1. The pilot's head struck and cracked the canopy transparency.

Photo 1: Final resting place

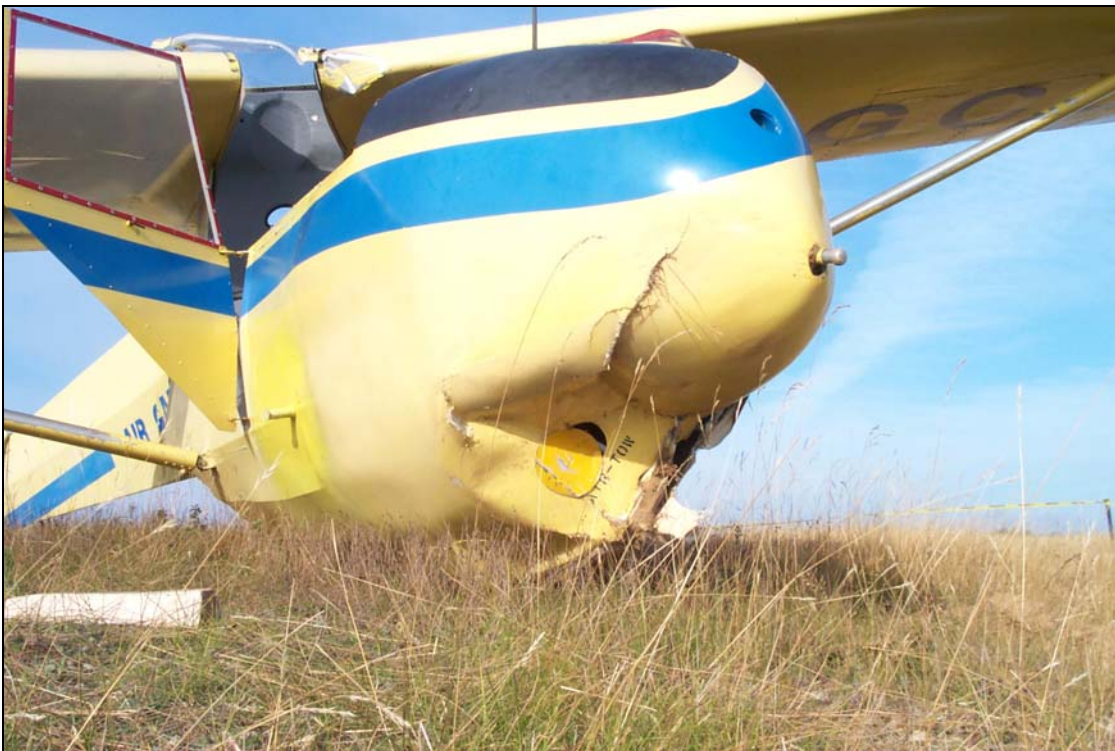
Photo 2: Nose damage

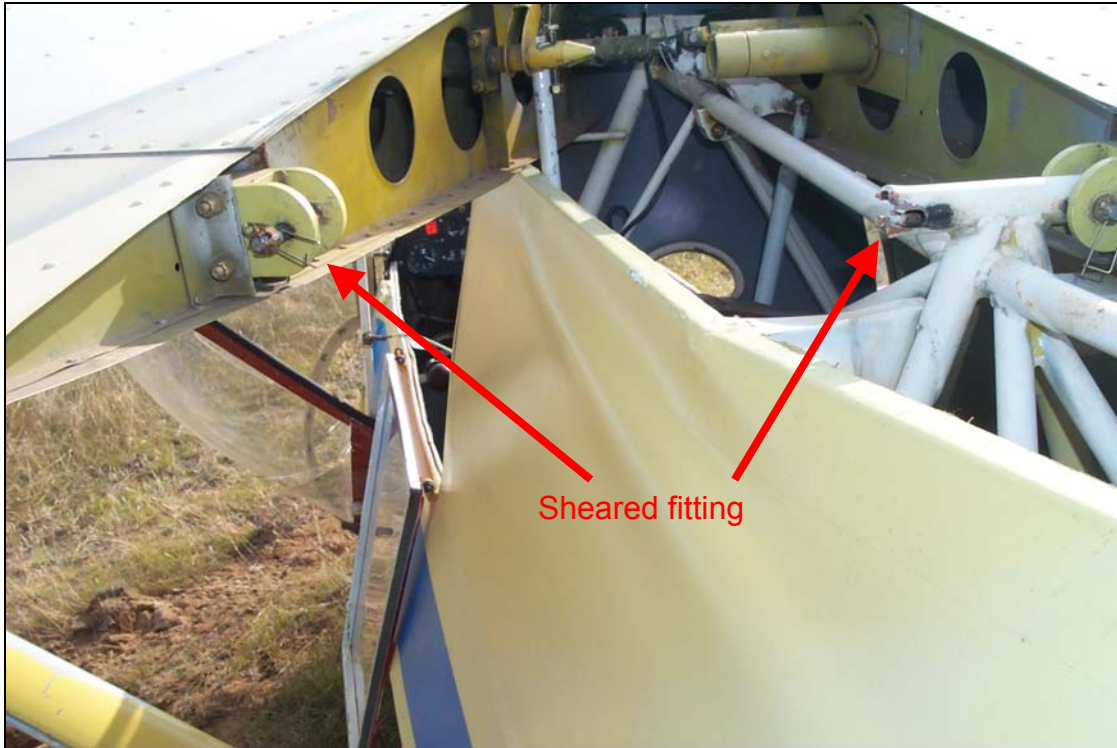
Photo 3: Rear spar attachment point

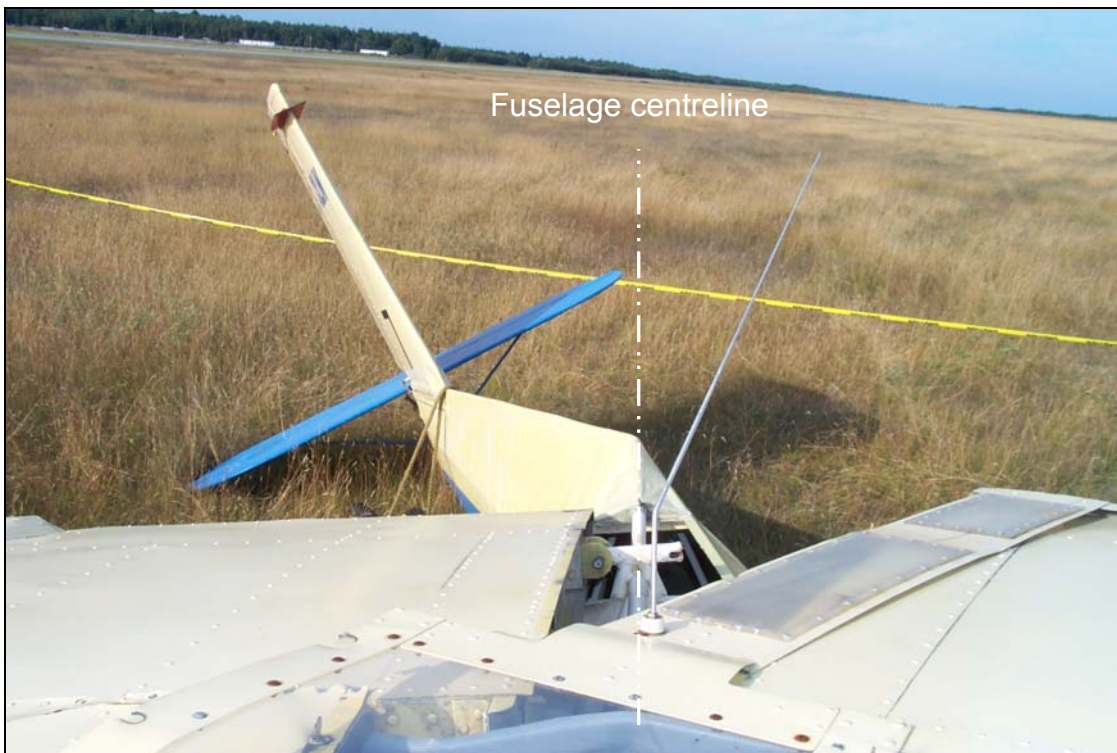
Photo 4: Rear fuselage damage
